PTPT REPORT NO. 78-14
AFPEA PROJECT NO. 78-P7-5

PACKAGING AND SHIPPING ANALYSIS OF THE
LN-12 INERTIAL PLATFORM

11 Jun 1978

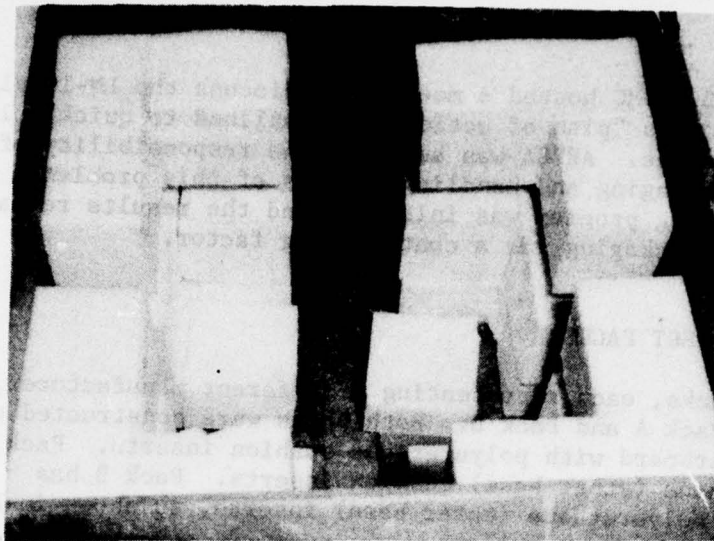
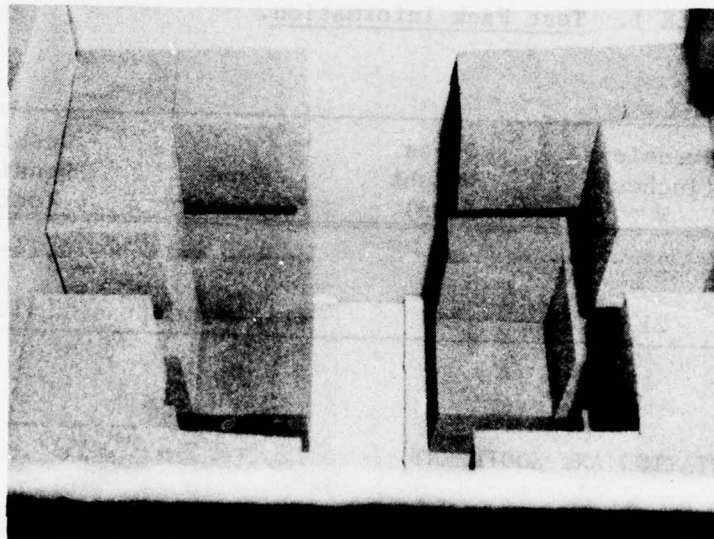
FIGURE 1. Photographs of Cushion Inserts.

The two test packs, each representing a different manufacturer, are identified as Pack A and Pack B. Both packs were constructed of corrugated fiberboard with polyurethane cushion inserts. Pack A has white polyurethane (ether base) cushion inserts. Pack B has charcoal color polyurethane (ester base) inserts, as shown in Figure 1.

The cushioning material thickness is 4 inches and the load bearing pad surfaces are each 5 x 5 inches. Each test pack included identically constructed inner cartons which nested in the cushion cavity. The size and weights of the test packs are listed in Table I.

a. Pack A

b. Pack B

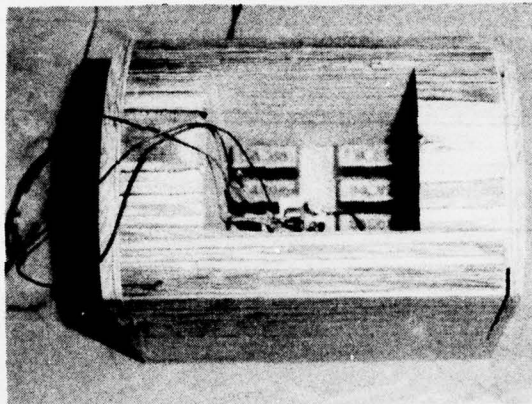
All tests, except as noted, were conducted in accordance with the Federal Test Method Standard 101B. A tri-axial accelerometer was mounted at the center of gravity of the simulated wooden model (Figure 2) to monitor shock and vibration during tests.

FIGURE 2. Photograph of Simulated Load with Accelerometers.

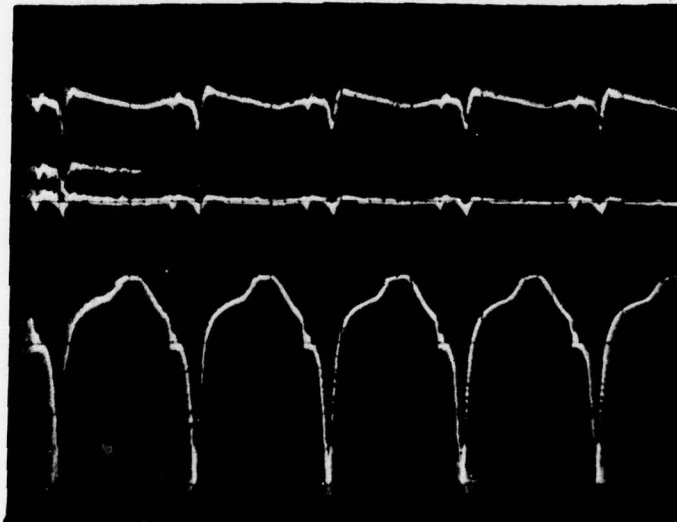
Resonant frequency data for each test pack is shown in Table III and the oscilloscope trace of the acceleration-time history for Pack A is shown in Figure 3.

FIGURE 3. Oscilloscope Trace for Pack A,
(5 G/cm (vert.), 0.1 sec/cm (horiz.))

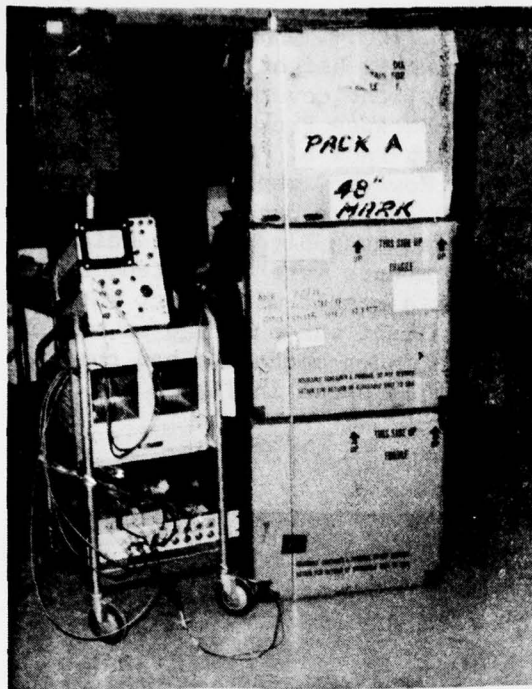
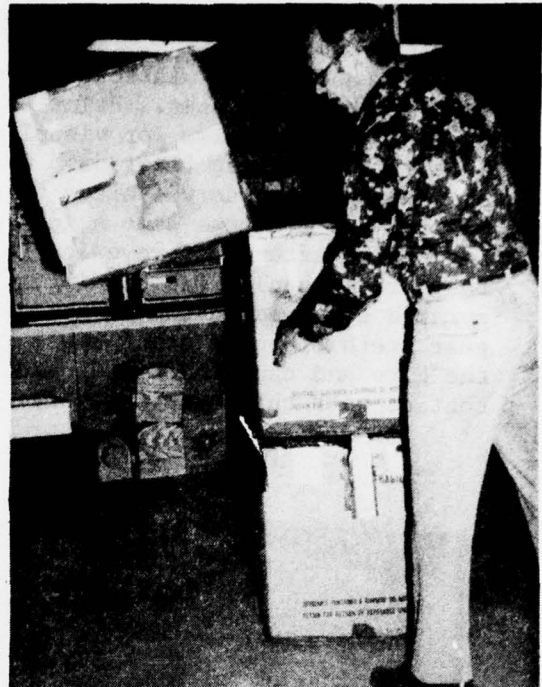
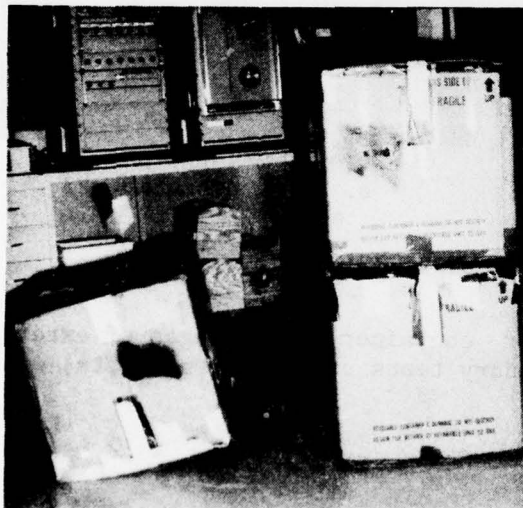
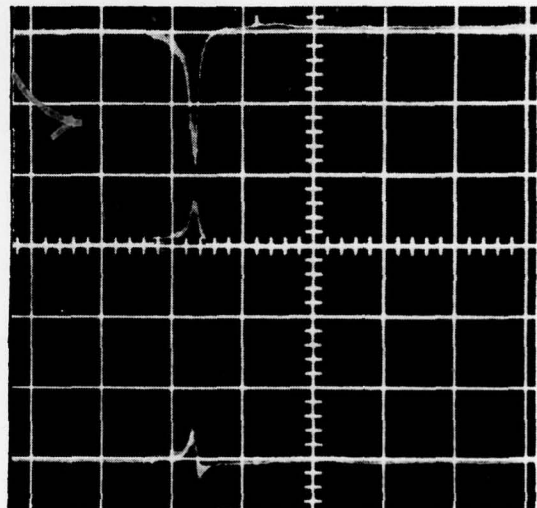
FIGURE 4. Photographs of Three-High Stack Drop Test.

Pack A was placed on the top of a three-high stack and manually tipped to simulate toppling as shown in the series of photographs in Figure 4. The resultant impact force on the top edge was 38.7 G.

a. Instrumented Pack on Top

b. Beginning of Drop

c. Drops on Top Edge

d. Oscilloscope Trace of Actual Drop

During the 15 March 1978 meeting at AGMC, a committee member recommended including stacking height instructions in the TPO to limit the stack to two high. Our test results support this recommendation and stacking height instructions should be included in all TPOs of fragile items.

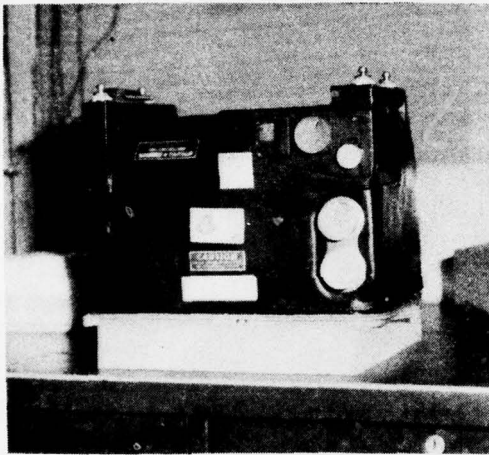
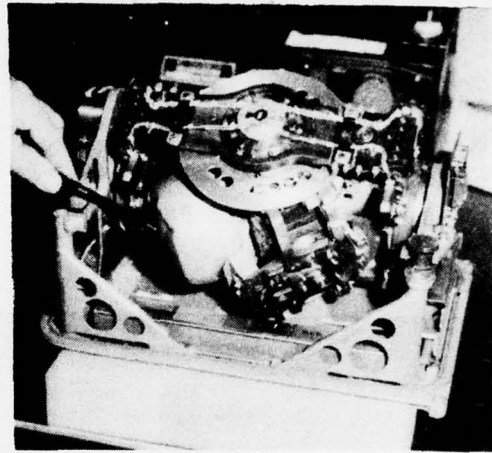
FIGURE 5. Photographs of LN-12 Platform

A serviceable LN-12 platform was dropped from a height of 48 inches in each of the test packs. Prior to each drop, the cover was removed to inspect the mechanism for visual damage. Because Pack A was found to be substandard, the first drop was made with Pack B. No visual signs of damage were observed after this drop. However, when the platform was dropped from the same height in Pack A, severe damage resulted. Inspection after test revealed that the gyro assembly was not balanced, the gyro mechanism was binding, the shock mounts were distorted, a scratch appeared on the large gear face as a result of contact with the gear teeth of an adjacent small gear and a dent was observed on one of the gyro end caps which indicated that the inner mechanism had come in contact with the outer assembly. The dent is shown in Figure 5.

a. LN-12 with Cover

b. Mechanism Exposed

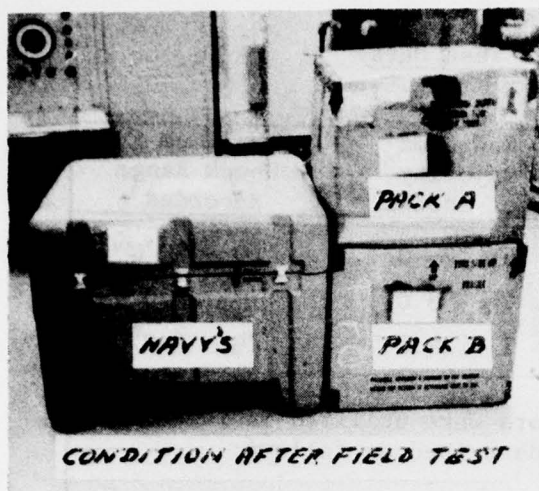
Three test packs (Figure 6), instrumented with transportation environment recorders (Figure 7), were shipped simultaneously from Wright-Patterson AFB, Ohio, to Nellis AFB, Nevada, via Logair, to monitor the transportation and handling environment of the LN-12 platform. The route included stops at

FIGURE 6. Field Test Packs.

The bottom cushioning material of Pack A was compressed to a thickness of less than 2 inches compared to negligible compression in Pack B. The top corner of Pack A was crushed, as can be seen from the photograph of the three test packs (Figure 6).

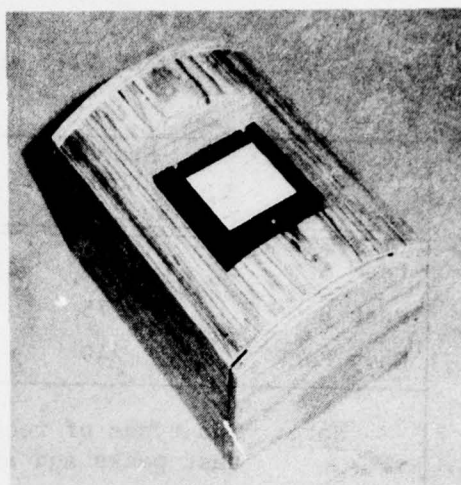
FIGURE 7. Environment Recorder.

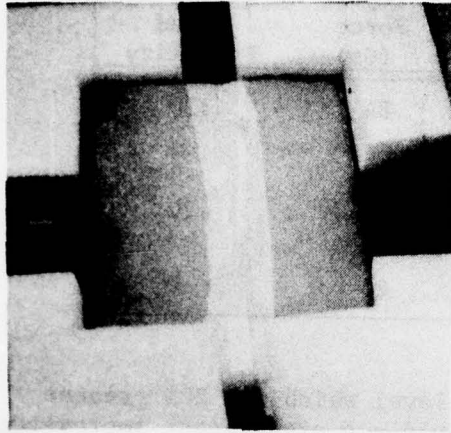
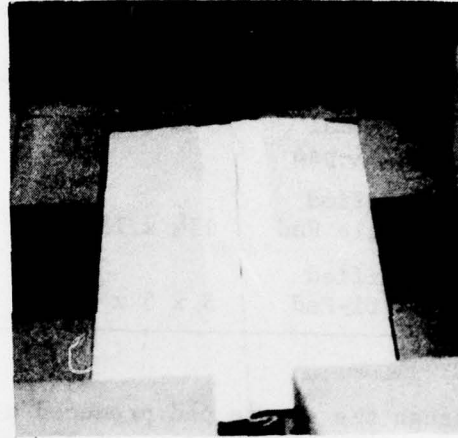
FIGURE 8. Photographs of Inner Carton.

Immediately after the test packs returned from the field test, the containers were opened and the position of the inner carton was photographed as shown in Figure 8.

Pack A

Pack B

As an interim corrective action, Pack A was modified to improve the cushioning capability of the bottom surface. The modification was achieved by replacing the four 5 x 5 inch bottom cushion sections of the bottom corner cushion assembly with a single cushion pad (15½" x 13" x 4"). The cushioning material was identical to the material in Pack B.

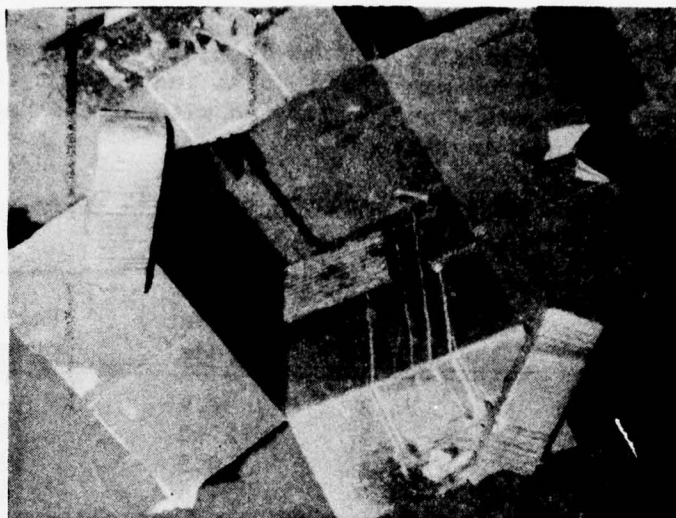
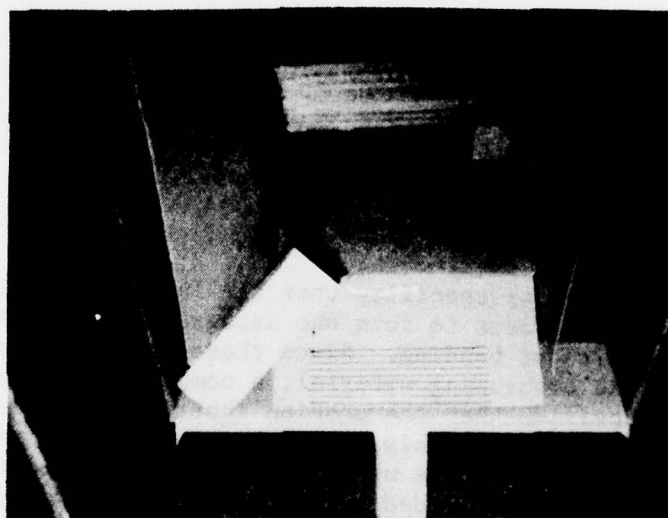
FIGURE 9. Photographs of Loose Pads.

During a tour of the AGMC facility, examination of incoming LN-12 platform packs revealed missing or loose fiberboard components in the inner carton. Pieces most susceptible to being lost or coming loose are the top fiberboard pads which separate at the bonded surface as shown in Figure 9a. Loose pads may also result from fiberboard ply separation as can be seen in the photograph of an unused pack as shown in Figure 9b.

a. Separation of Bond

b. Separation of Fiberboard Ply

If the pads are loose or missing, the LN-12 platform can move within the fiberboard carton, which may result in an increase in the shock level. The test packs were dropped with and without the pads and produced results as shown in Table IX.

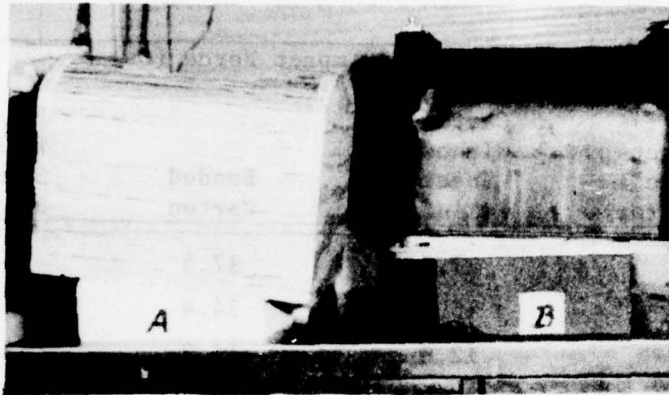
Data on the properties of the cushioning materials from each pack are summarized in Table XI. Details on the evaluation of the material properties are presented in an AFPEA "Memo for Record", dated 10 May 1978. The TPO specifies that the cushioning material is to be 2 pcf ester base polyurethane flexible foam. To demonstrate the difference between the materials in the two packs, a load with the same weights and surface areas was placed on the materials from each pack. The material from Pack A would not support the load without toppling unless it was manually balanced, as shown in Figure 10. The load on material B remained upright.

FIGURE 10. Photo of Loaded Cushion

1. Investigate the possibility of using a multipurpose reusable container similar to the pack used by the Navy to ship their avionics equipment.
2. Monitor the progress of the new packs through the calendar year 1978.
3. Include the Indent Load Deflection (ILD) requirement for the cushioning material, in the TPO.
